**INSTALLATION RESTORATION PROGRAM
PHASE II - CONFIRMATION/QUANTIFICATION
STAGE 1**

CANNON AFB, NEW MEXICO 88103

FINAL REPORT
FOR
CANNON AFB, NEW MEXICO

VOLUME 1. TEXT

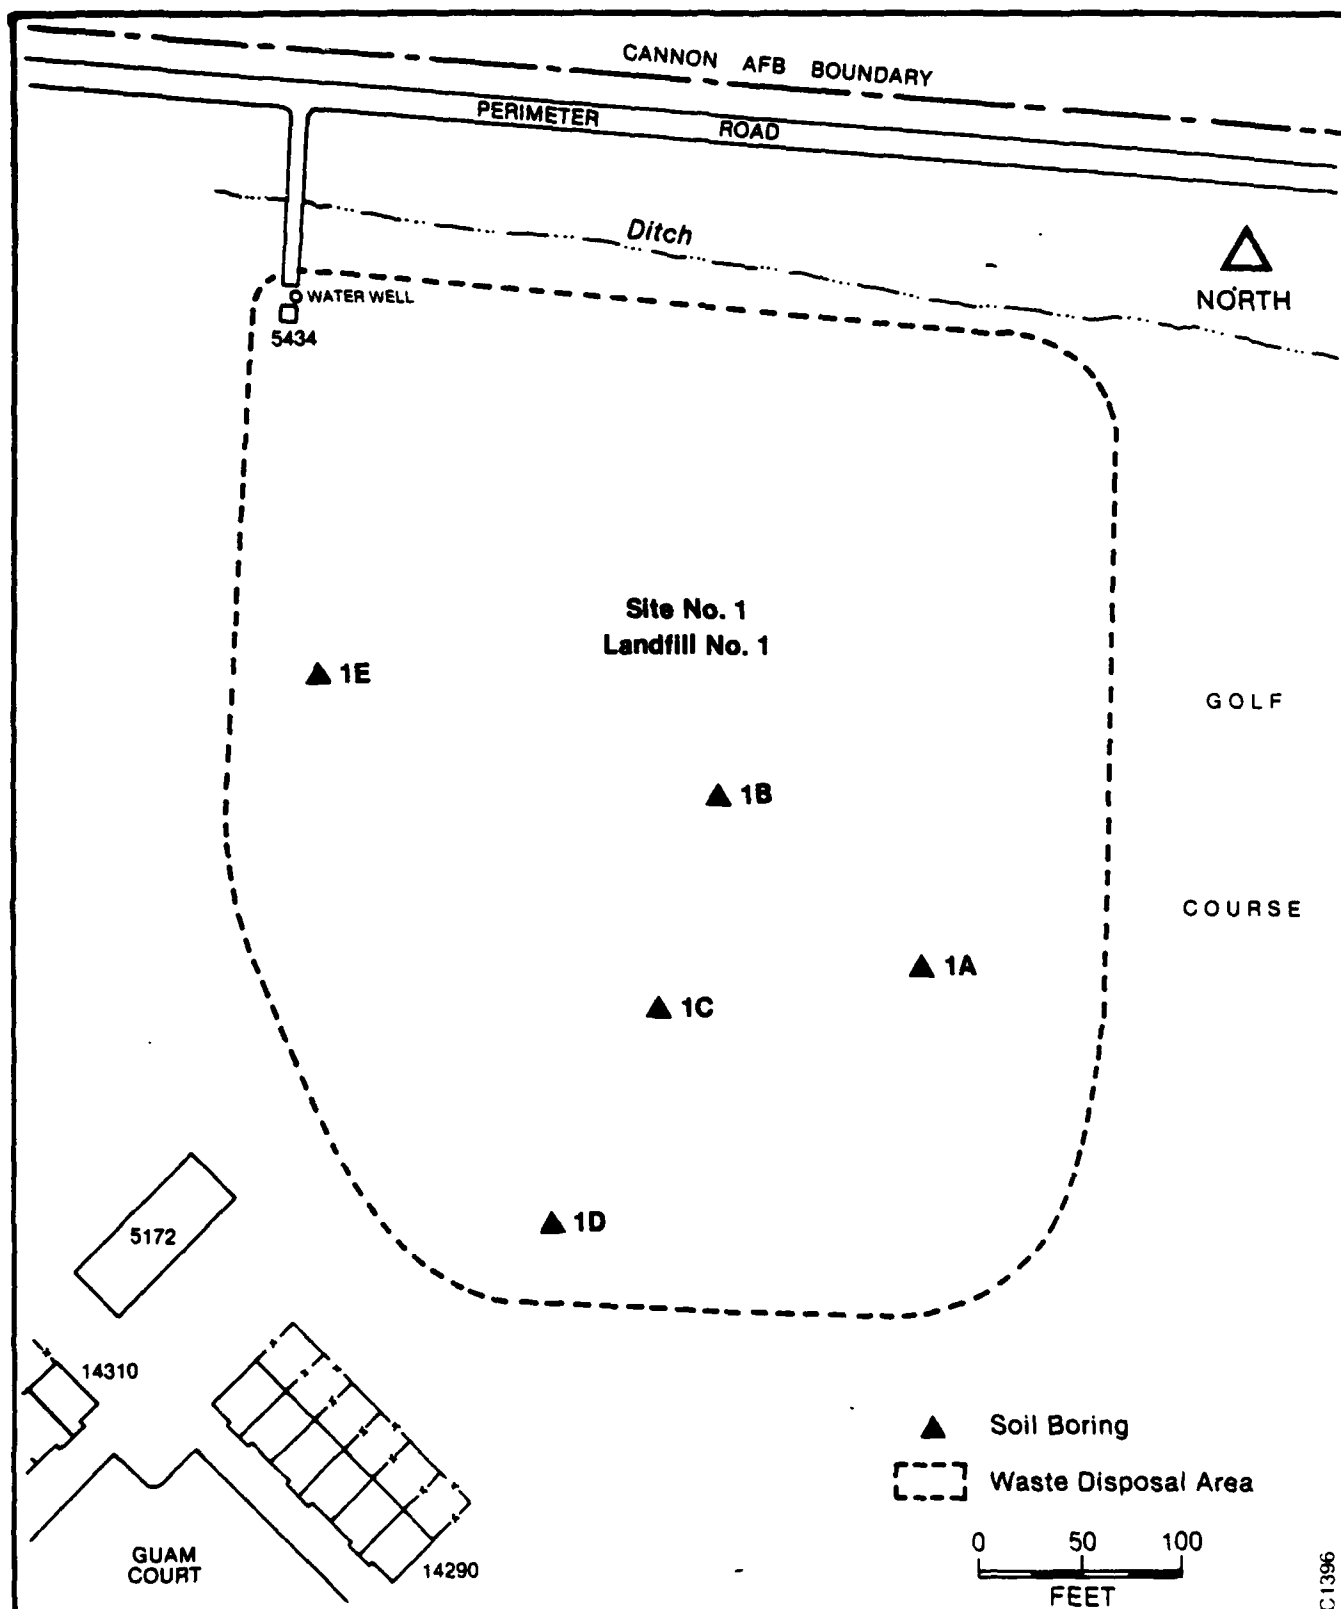
Figure 4-2. Soil Boring Locations, IRP Phase II Stage 1, Site No.1, Landfill No. 1, Cannon AFB, New Mexico

Site 1: Sampling at Landfill No. 1 found no purgeable halocarbons or aromatics. The total concentrations for metals fall within the normal soil ranges except for selenium which is moderately elevated. Oil and grease levels are elevated above background values in surface soil samples.

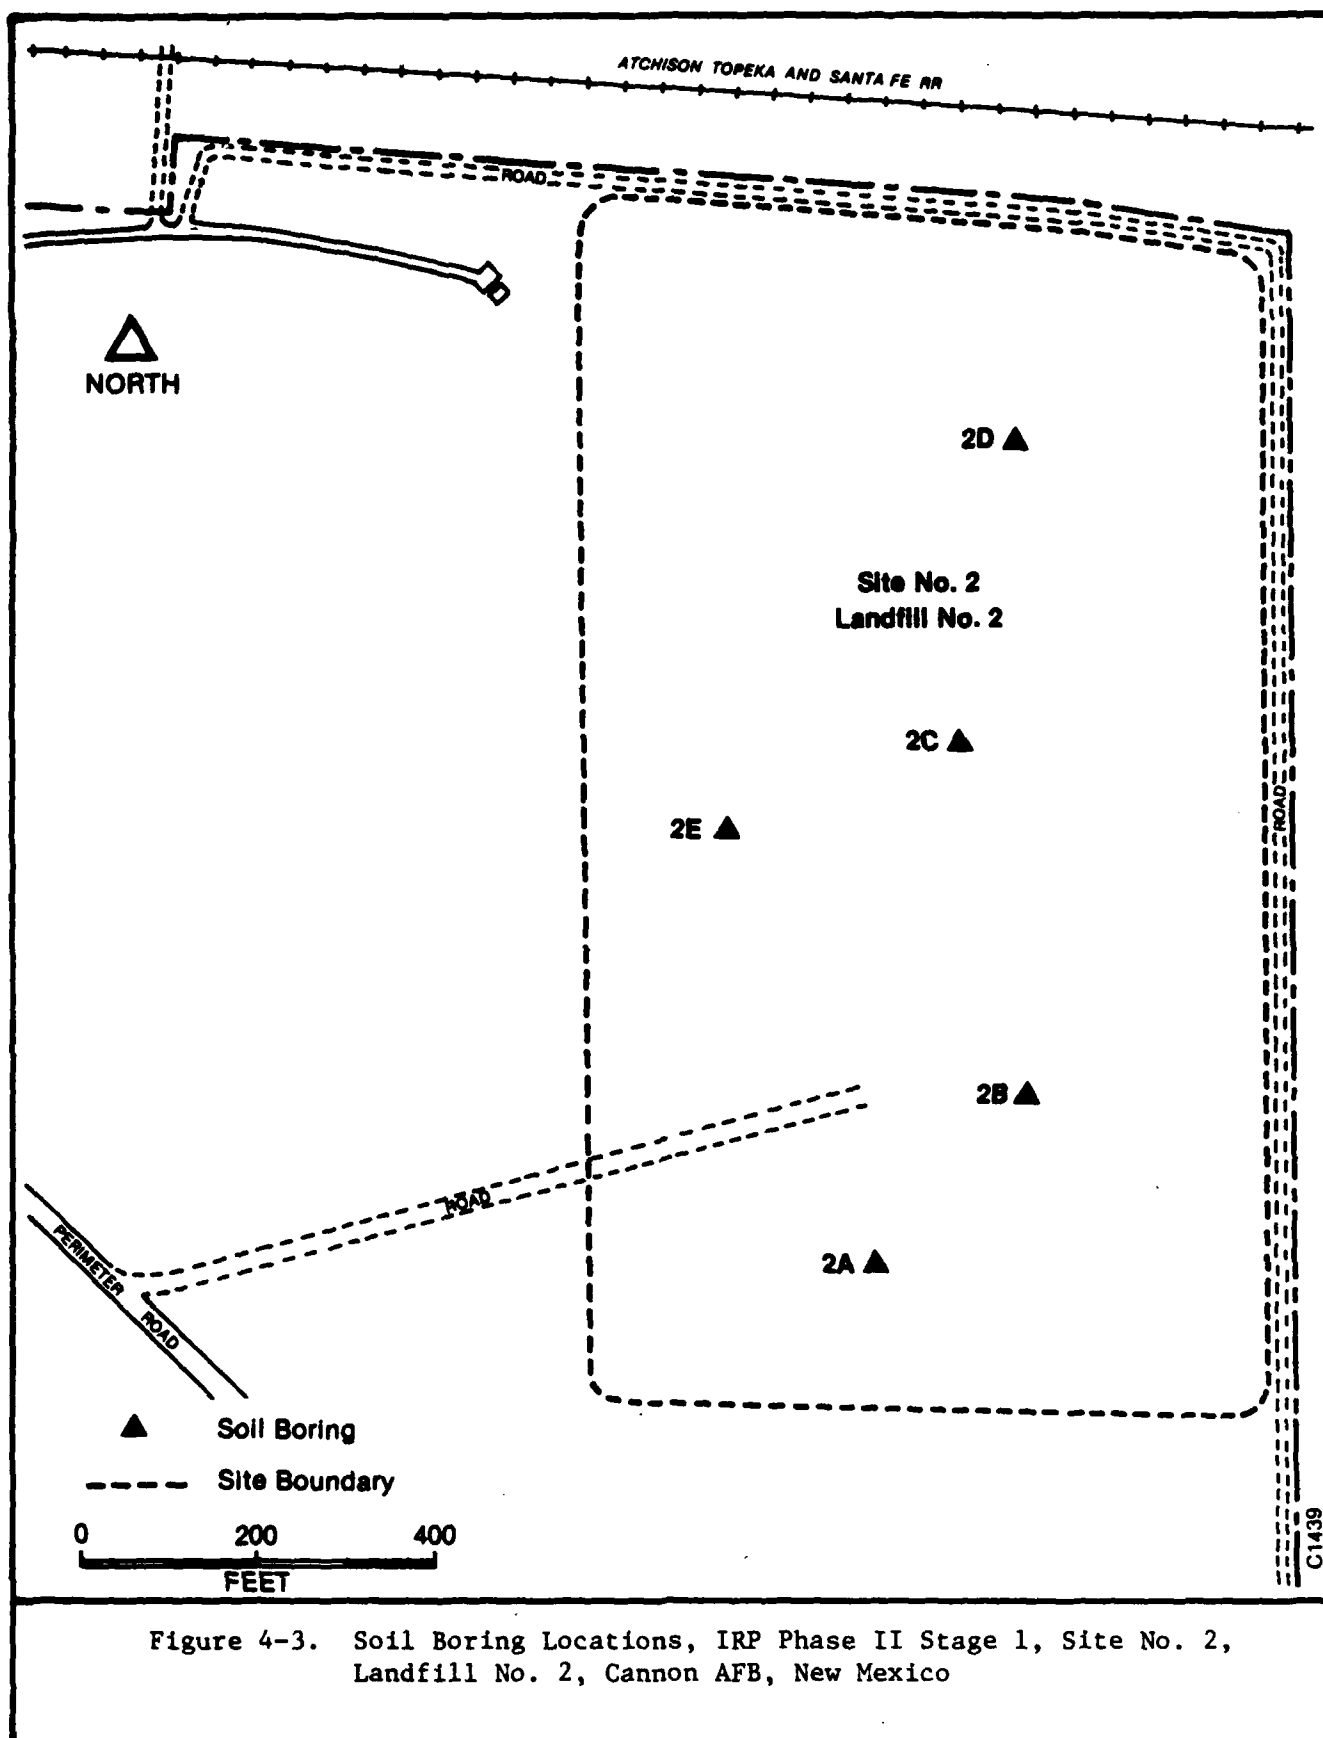
Figure 4-3. Soil Boring Locations, IRP Phase II Stage 1, Site No. 2, Landfill No. 2, Cannon AFB, New Mexico

Site 2: The samples from Landfill No. 2 revealed no purgeable halocarbons or aromatics. No oil or grease concentrations were found. The metals concentrations were within the normal range for soils except for slightly elevated levels of barium and selenium. The barium results from natural weathering in the semi-arid soils. The selenium is found in the shallow soils and remains remote from ground water.

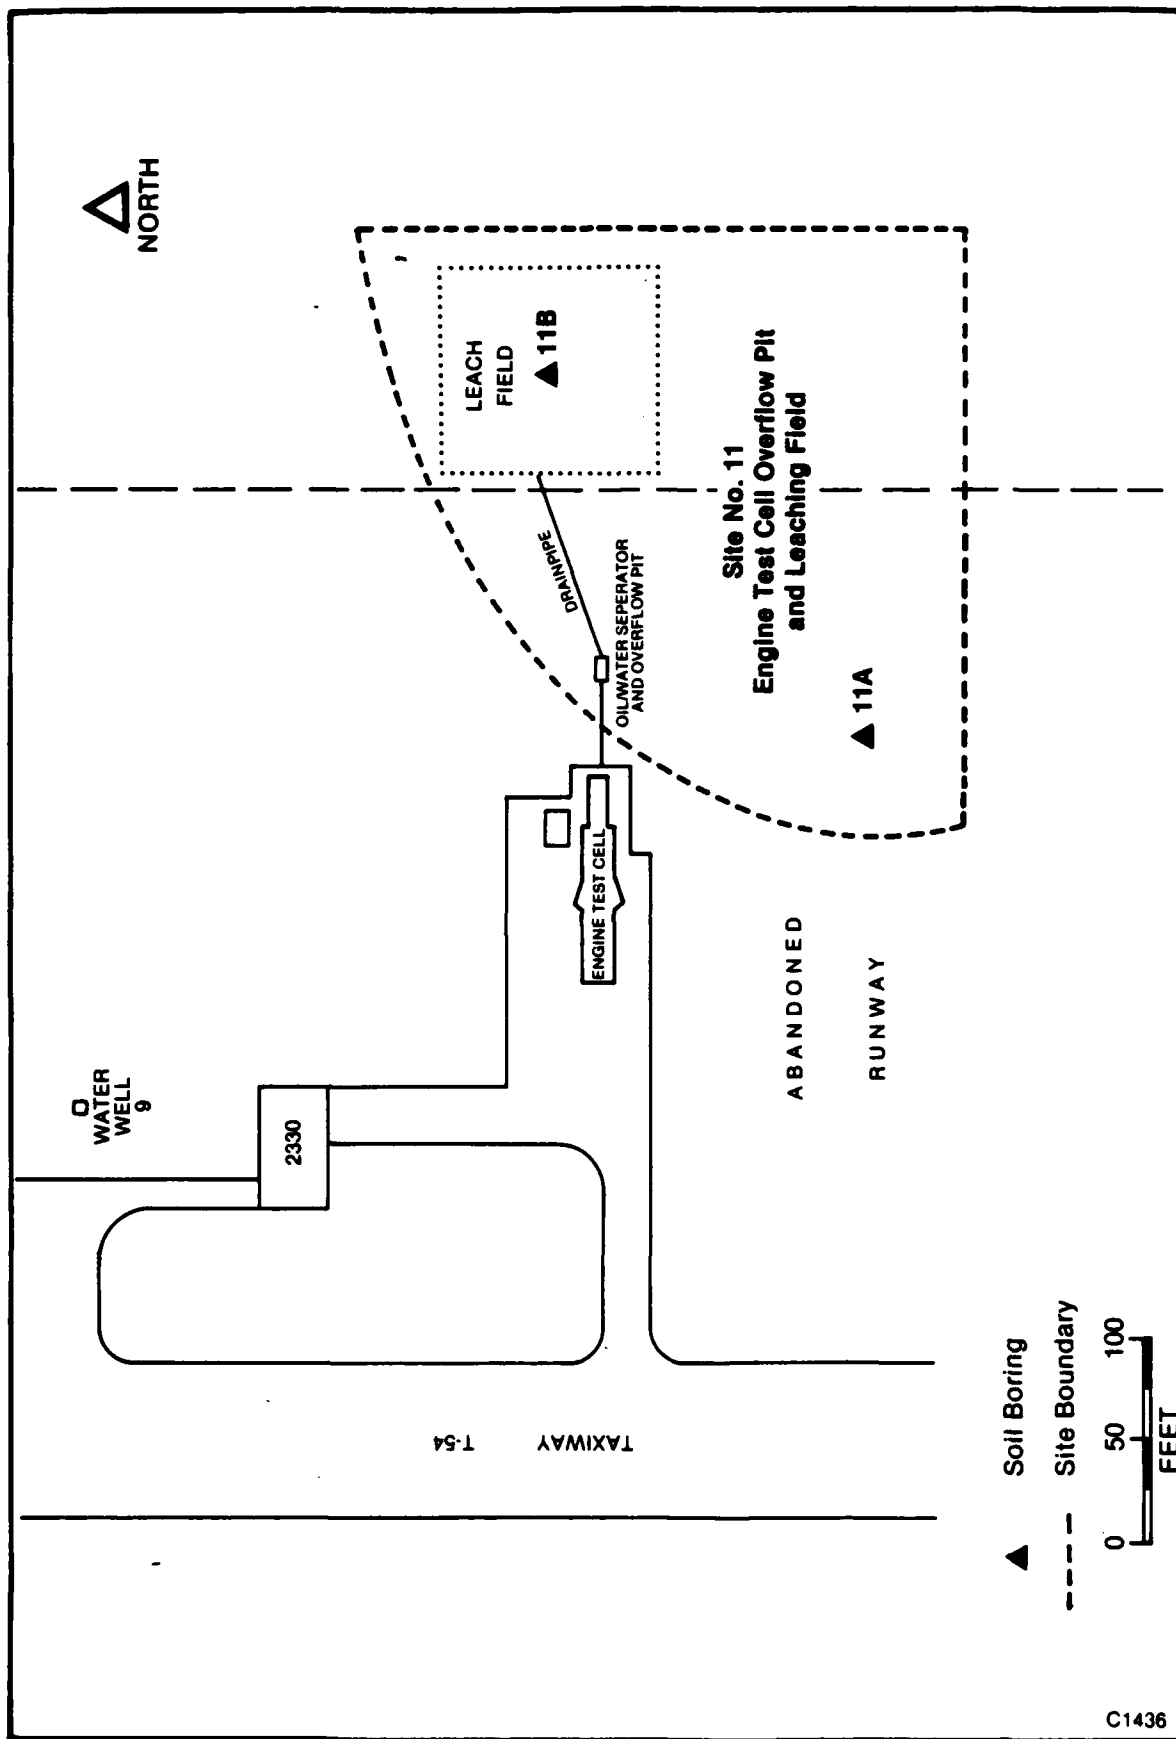
Figure 4-17. Soil Boring Locations, IRP Phase II Stage 1, Site No. 11, Engine Test Cell Overflow Pit and Leaching Field, Cannon AFB, New Mexico

Site No. 11 was identified for Phase II Stage 1 investigation due to the known disposal of hazardous material, the observed contamination in the overflow pit, and the site location, within 300 feet of potable water well No. 9. Two deep soil borings were installed to evaluate the environmental impact of this site.

Site	Recommended Action(s)	Rationale
No. 11 Engine Test Cell Overflow Pit and Leach Field	Install three deep soil borings in the vicinity of the old oil/water separator and drainpipe. Collect soil samples from each borehole immediately above the caliche; five feet into the caliche; and immediately below the base of the caliche. Analyze all samples for porosity, pollutant metals, purgeable organics, and oil and grease. Also, analyze water samples from the evaporation pond for purgeable organics.	The oil/water separator sump at this site was not sampled for Priority Pollutant Analysis during the Phase II investigation. Available data, though all negative, provide insufficient basis to dismiss the site from further activities as the extent of potential contamination is not adequately defined.
No. 12 Stormwater Collection Point	Install three deep soil borings along the southern perimeter of the Stormwater Collection Point to a maximum depth of 200 feet. Collect soil samples at 10 foot intervals and analyze for priority pollutant metals using the EP Toxicity Test.	A large proportion of surface runoff originating on-base is routed to the Stormwater Collection Point. Sediment samples collected from the basin indicate elevated levels of heavy metals exist in the sediment. The water body in the basin could potentially drive these heavy metals deeper into substrate and aquifer below.

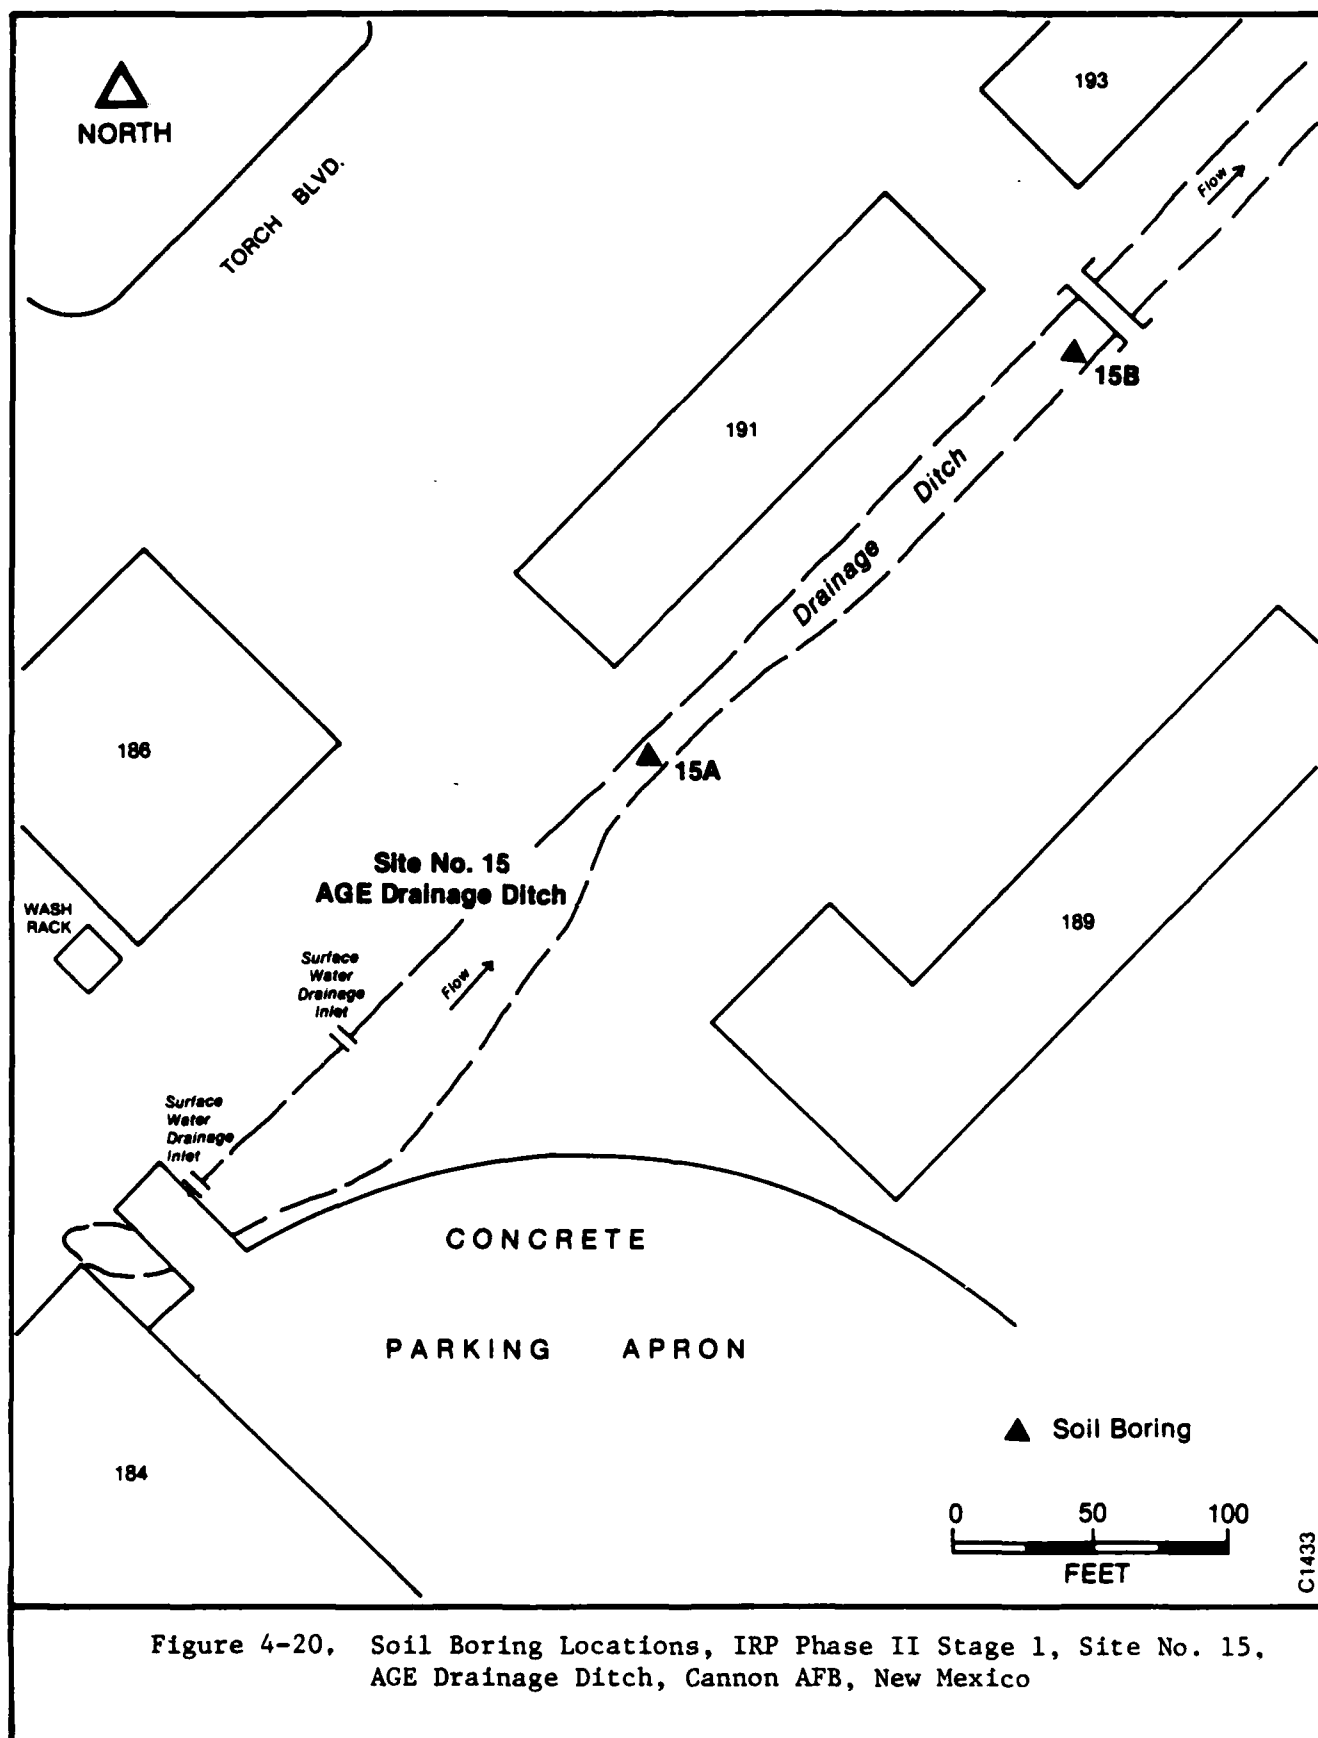
Figure 4-20. Soil Boring Locations, IRP Phase II Stage 1, Site No. 15, AGE Drainage Ditch, Cannon AFB, New Mexico

The AGE Drainage Ditch was identified for Phase II Stage 1 action because of the known disposal of hazardous waste and presence of observable contamination. In addition, the ditch is located within 1600 feet of the installation boundary. Two deep soil borings were made along the Drainage Ditch
